SERVICE BULLETIN

Bulletin n°10-2008 - LEVEL : **INFORMATION**
SPEED - SYSTEM

Concern: Speed-System In-Flight Trim Serial No/s: 1 - 70

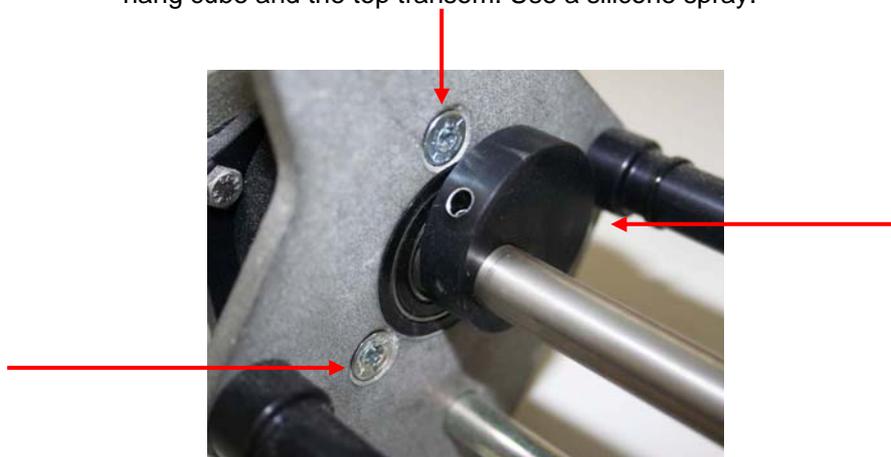
Problem: Possible loosening of the milled cap-screw M5x12 fixing the aluminium shouldered rings at the wing plates. The heads of these screws are in close proximity to the high density plastic hang cube of the hang bracket.

Consequence: If one of these screws is loosened of more than one turn, its head will block the rotation of the off-centre pivot mechanism; making it impossible for the hang cube to be 'trimmed'. The circuit breaker will activate.

Solution: Check the tightness and security of these screws every 100 hours.

Method: Detach the wing (CF Pilot Operators Handbook or 'Manuel d'Utilisation du tricycle'). Tighten the six (6) cap-screws. It will be necessary to turn the off-centre pivot mechanism slightly (to use the electric trim switch of the Speed System). An Allen Key of very good quality should be used, taking care to insert the Allen Key to the maximum penetration depth. Tighten the screw as tight as possible, without deforming the screw. (It is not possible to give a torque setting as the access does not make it possible to use a torque wrench).
